FridgeTek

Work Report.

Chiller Mod: YK HCDGHY65CRES Ser: GGJM018929
SSS Mod: 26LK Ser: EIR 509

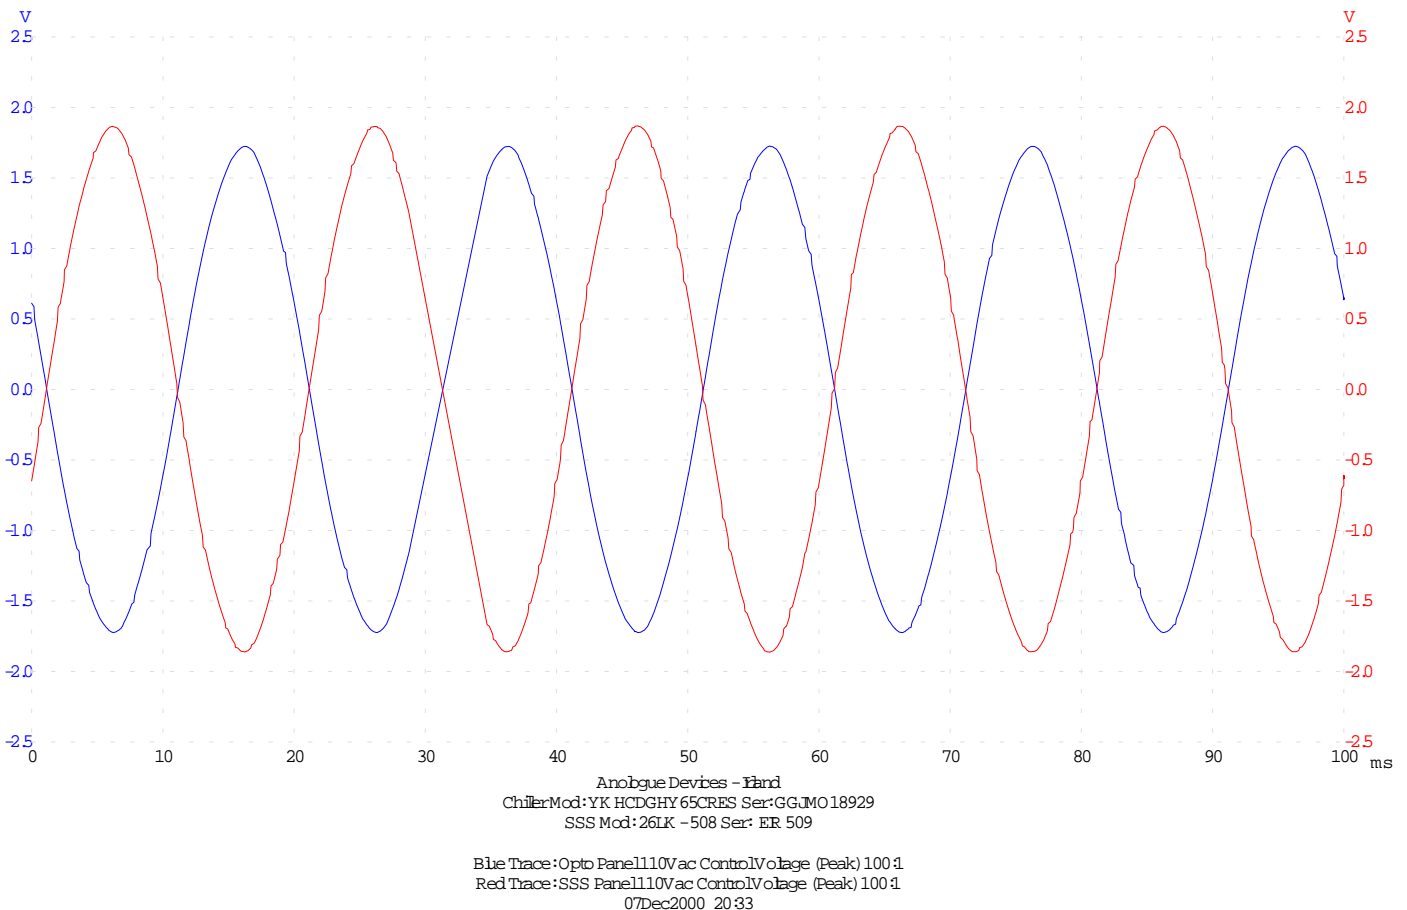
Figure 01.

The output from each transformer showed that they were out of phase by 180 deg, giving a potential difference of 250Vac RMS. Figure 01 shows an Oscilloscope Log of the phases.

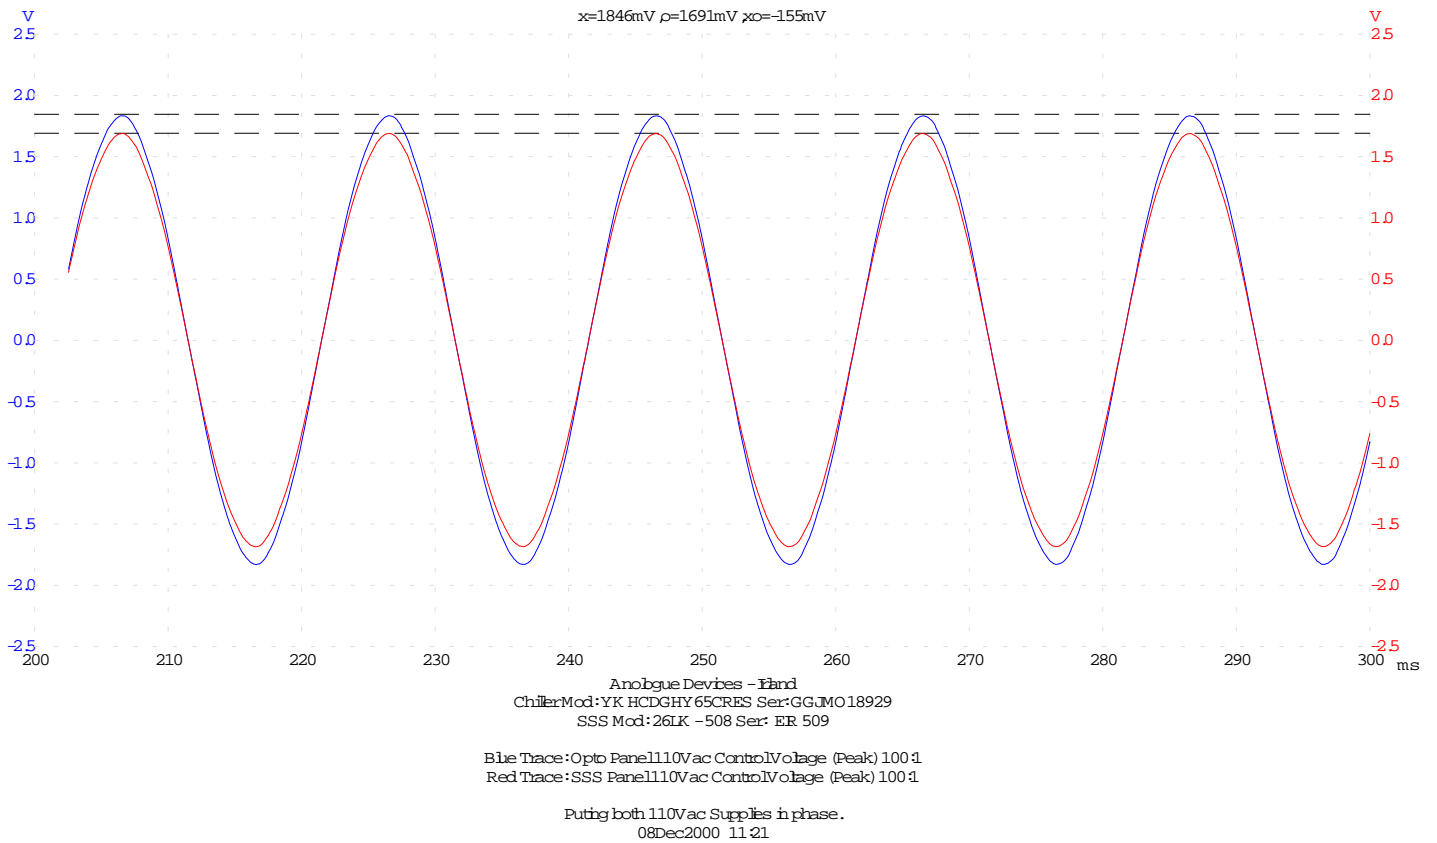
We decided to change the additional transformers primary tap-in's to bring both control transformers secondary outputs in phase. This was successful but there was still a potential difference of around 11 Vac RMS between the outputs. Refer to Figure 02.
