Chiller No1. Mod: YKCEDBG4 5CKE Ser: PBKMG41205
Chiller No2. Mod: YKCEDBG4 5CKE Ser: PBKMG41204
Chiller No3. Mod: YKCEDBG4 5CKE Ser: PBKMG41203

Please find a breakdown of the problems encountered. The above site suffered from Power Faults (Half Phase Trips) on a running Chiller during the starting of a second. Initial investigations of the Solid State Starter Logic Board, showed irregularities on the Current Transformers and Line Voltage waveforms on the running Chiller during the above event, as identified by Figure 01 capturing a trip.

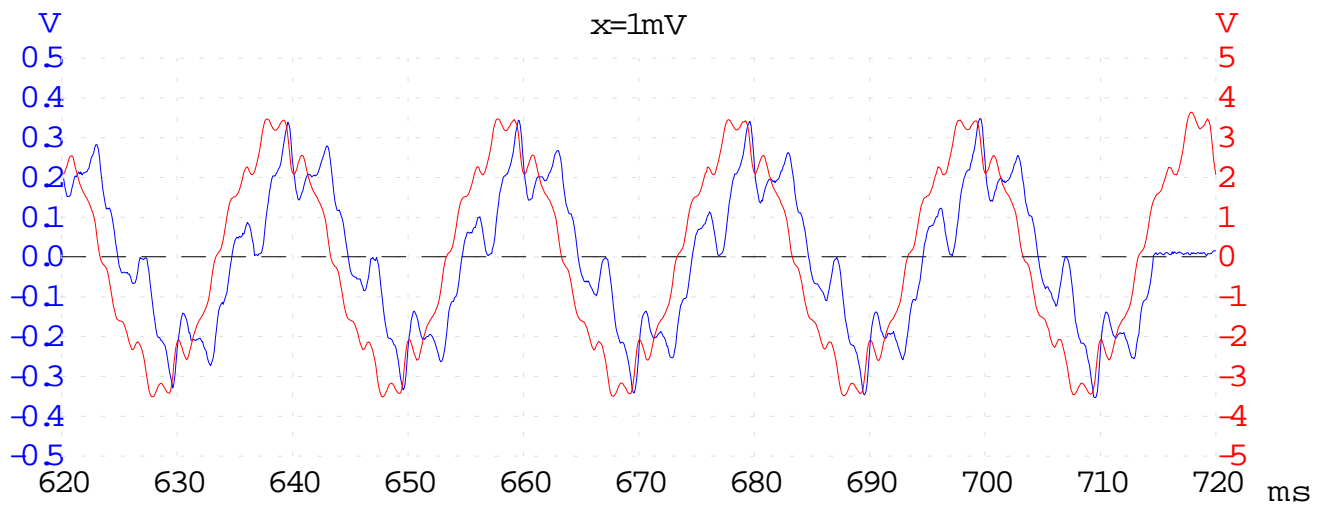
Figure 01.

Compressor 3 Starting -Compressor1 Running 40% FLA .
19Jun2001 13:18

Further investigation showed that the starting Chiller was inducing a harmonic on the running chillers voltage supply, hence the whole 415 Vac network supplied by the 6.6kV Chiller Transformer. This in turn is initiating additional SCR switching on the running chillers motor. This switching is prevalent at lower loads and is current going to 0 Amps through the SCR prematurely, not additional gating of the SCR. This can be explained as the Motors back EMF being greater than line voltage and current trying to flow out of the motor to the 415 Vac network. This flow in turn is being stopped by the bias of the SCR's hence the 0 Amp current

draw we are seeing in the incorrect places.

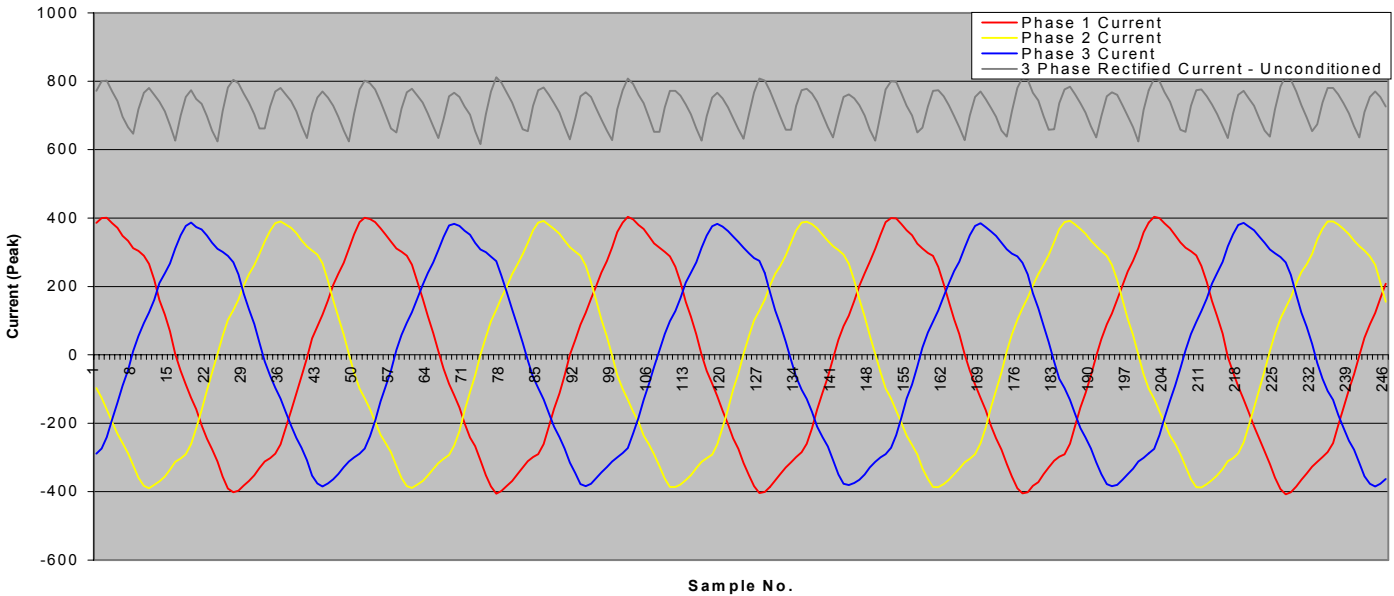
Figure 02.

As part of the Half Phase Safety circuit, the Solid State Starter Logic Board monitors the three current phases. It rectifies the 3 signals and applies a differential algorithm to it. It looks at the difference between the maximum and minimum of the rectified signal. Find following actual representations taken from site logs, calculating the 3 phases rectified waveforms based on the above captured trip as per Figure 01. These are Figure 02, one second before the second Chiller starting and Figure 03, during the second Chiller starting capturing the running Chiller trip.

Normal Running Conditions

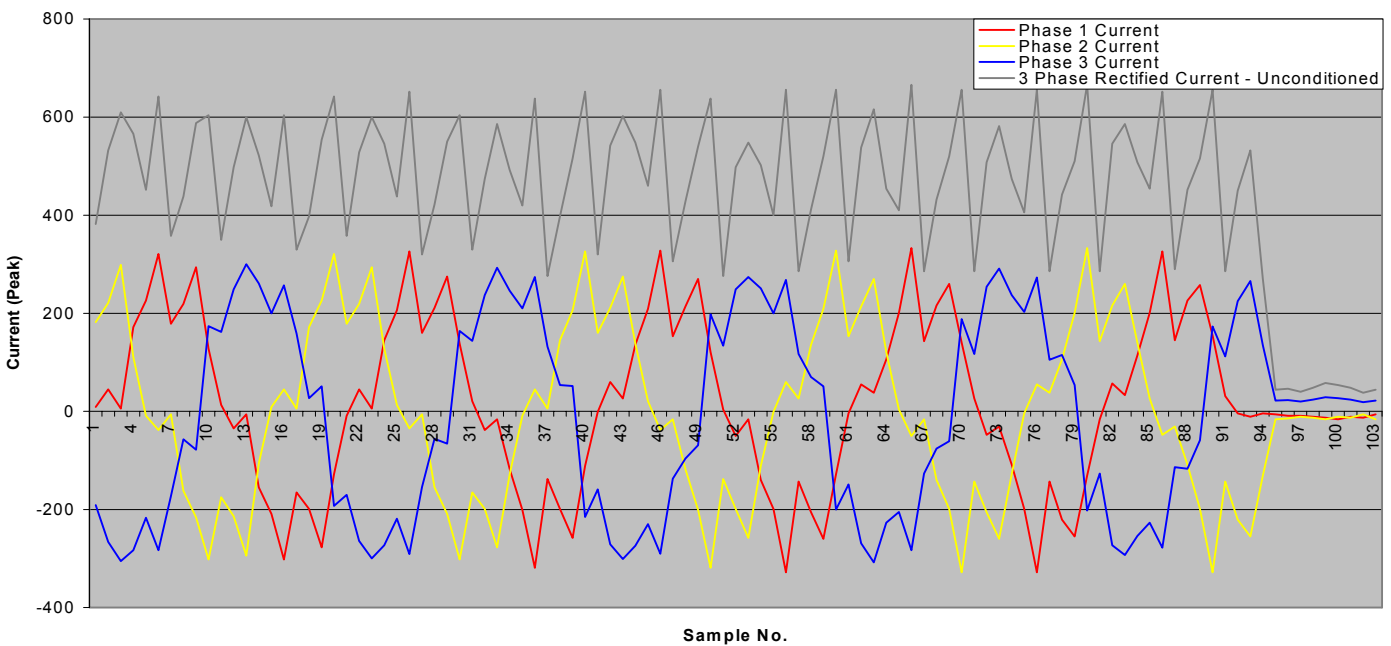
Figure 03.

Captured Trip Condition

It can be seen from figures 02 & 03 that the additional SCR switching induced by the starting harmonic on the running Chiller, causes the 3 phase rectified waveform to distort to a level where the Half Phase Trip is invoked.

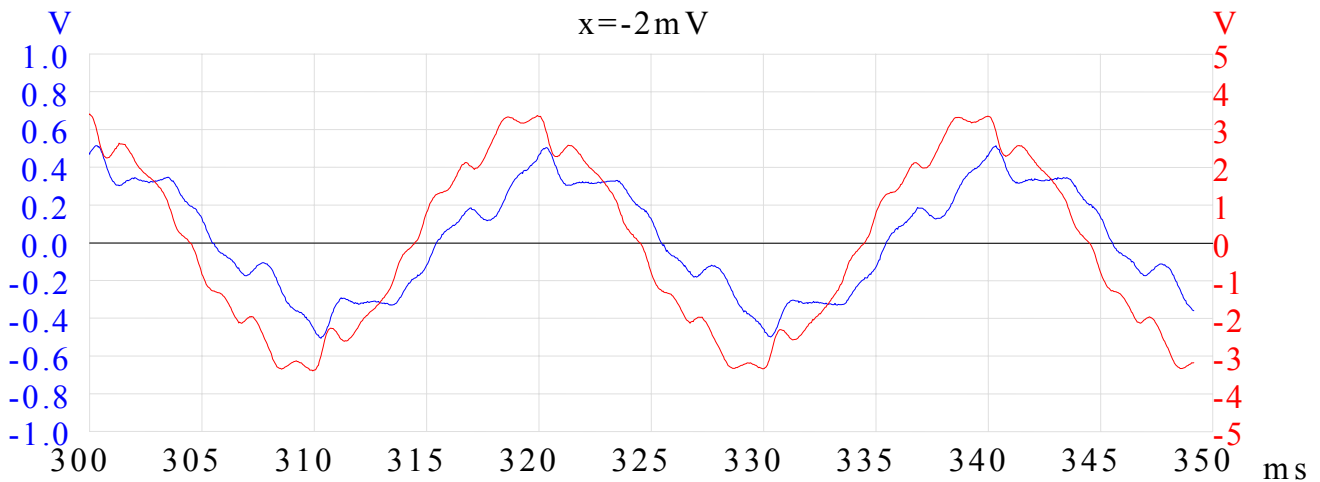
At higher loads there is no additional switching, but the distortion is still present having amplitude offset as reflected in Figure 04. This is due to the Motors back EMF being closer to the line voltage and current flow through the SCR's not prematurely going to 0 Amps.

Compressor 3 Starting - Compressor 1 Running 70% FLA.
19Jun2001 14:21

Fundamentally the running compressor motor is decelerating during the starting of another compressor. This is due to the Voltage Distortion on the 415Vac Network during the start and the reduced resultant RMS Voltage available to the running compressor motor.

These events all point to the choler's 415Vac network being undersized to cope with a running compressor and the starting inrush of another, this shortfall I suspect to be the 6.6kV to 415 Vac transformer.

Currently the site has ensured that the running compressor is at 70% FLA before the second Chiller is started, to overcome the running Chiller tripping on Half Phase.

I do not think it acceptable to leave the above short-term fix as a final solution. The waveform distortions are still present and effecting the running Chiller even at this higher loading. I cannot say that any damage will be incurred to the Driveline or the system as a whole if no further action is taken. I have forwarded this report to the manufacturers Product Support Team to comment on whether this is acceptable and in turn if it invalidates any warranties.
