Chiller No1. Mod: YKFBFAH65CSD Ser: PLGMH50288
 Chiller No2. Mod: YKFBFAH65CSD Ser: PLGMH50294
 Chiller No3. Mod: YKFBFAH65CSD Ser: PLGMH50287
 Chiller No4. Mod: YKFBFAH65CSD Ser: PLGMH50290

Following on from my site visit last week, please find a breakdown of the problems encountered. The above site suffered from Power Faults on a running Chiller during the start sequence of another. Initial investigations of the Chillers CM2 Motor Protection Module's three-phase rectified input signal, showed irregularities. We would expect a 300Hz ripple (3.3mSecond period) on the input signal, denoting the rectification of the 3 Current Transformer signals from each of the phases to the motor. With the aid of an oscilloscope we can see that we have only a 150Hz ripple (6.6mSecond period) with a higher amplitude than we would expect. Refer to Figure 01.

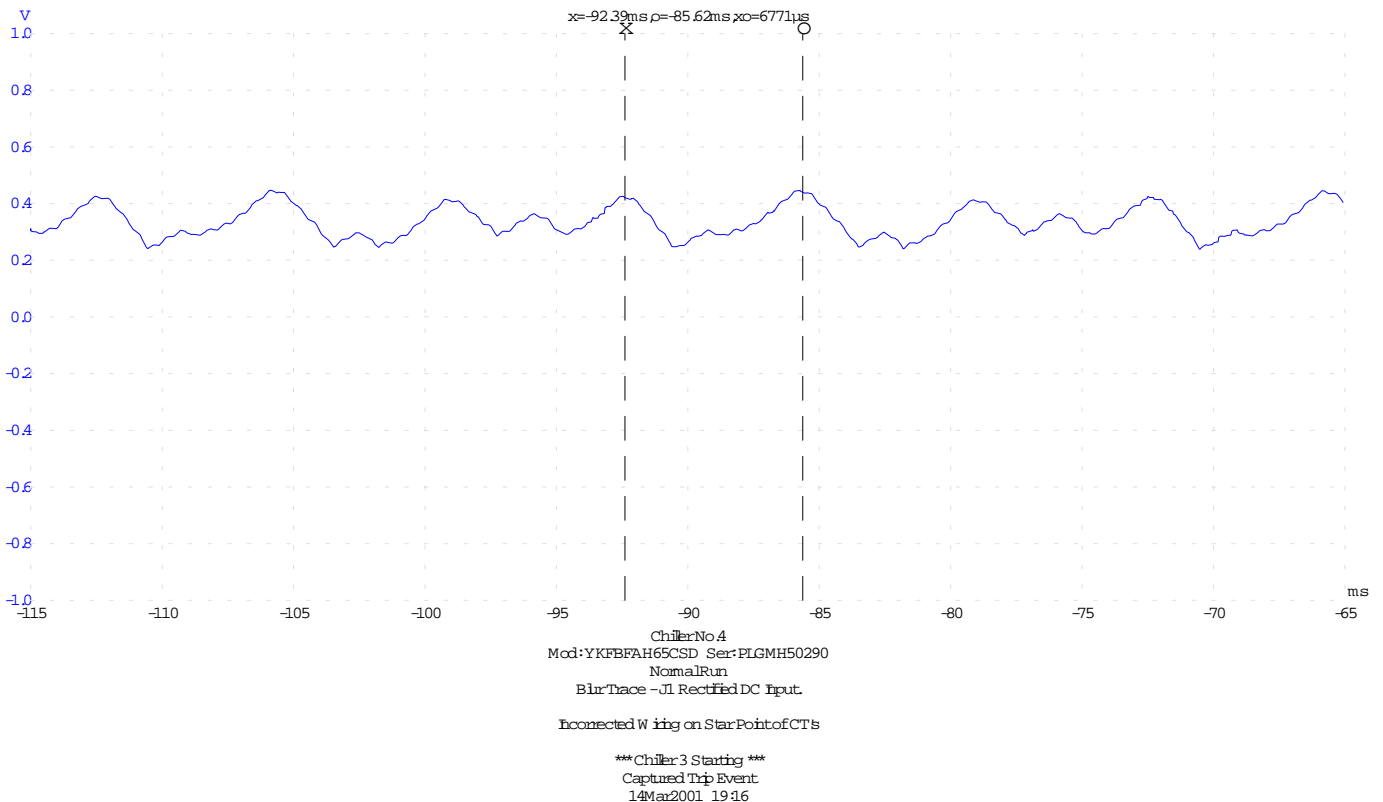
Figure 01.

Further investigation showed that the star point on the CM2 Module's Current Transformers had been earthed. This mis-wiring caused the loss of half the CT's Signal to the three-phase rectifier with a resultant reduction on it's output RMS signal. The manufacturer overlooked this mis-

wiring at the commissioning stage and the CM2 Module was inadvertently mis-calibrated. This had no detrimental effect on chillers or motor's safety protection circuits, as this mis-calibration actually made the CM2 Modules Safety levels twice as sensitive to tripping, as seen on site.

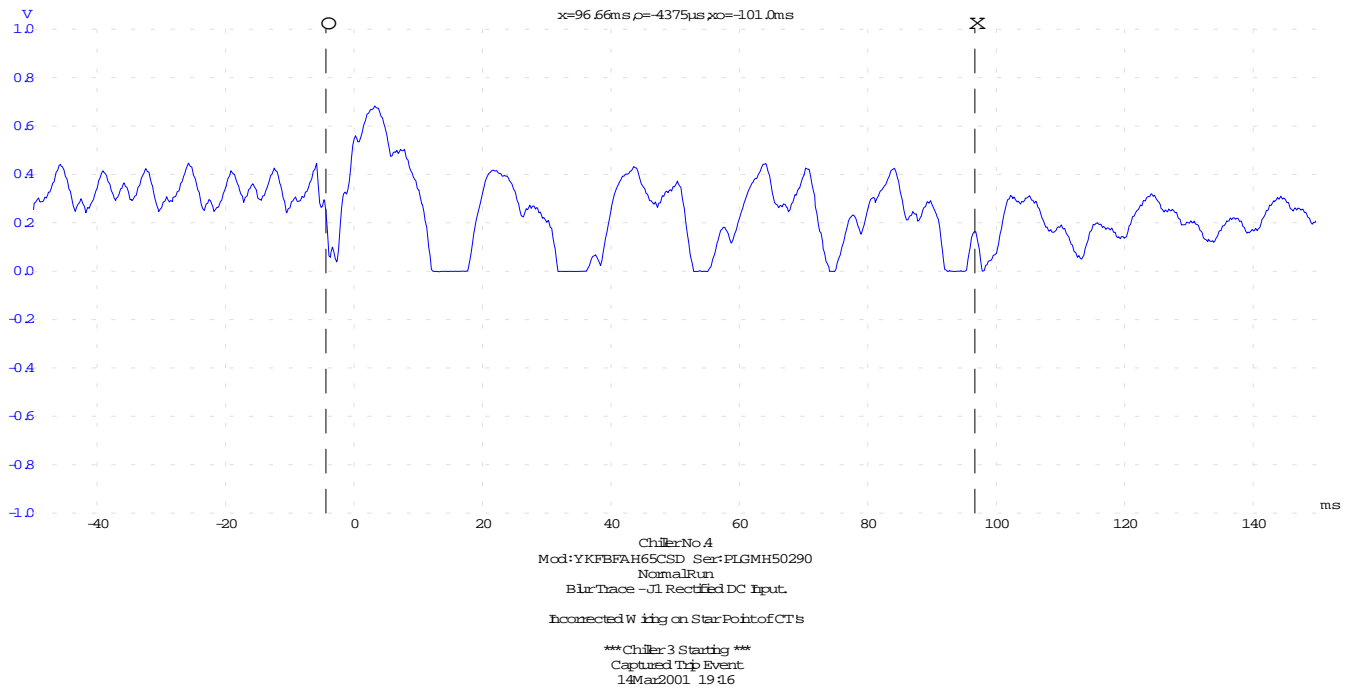
We actually captured a trip event on a running Chiller with the mis-wiring still in place, as reflected in Figure 02. The whole event took around 100 m seconds from initial start of the other Chiller to the running compressor's contactor dropping out.

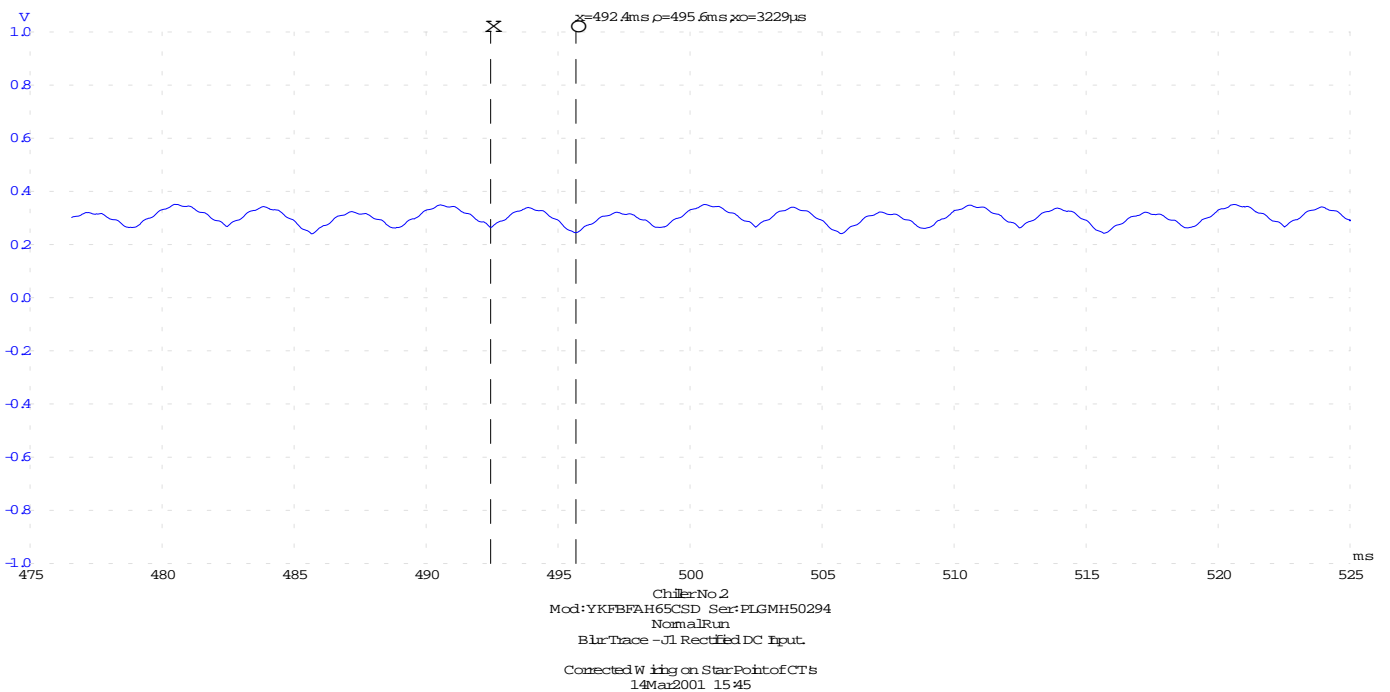
After removing the Earth lead from all the chillers CM2 Modules CT's Star points, the correct waveform was captured as per Figure 03.

All 4 Chiller CM2 Modules and burden resistors were recalibrate to the Alan Bradley current readings. The chillers were tested over several starting and running conditions, which proved successful until there were 3 compressors running lightly loaded and the 4th being started. Again a Power Fault Shutdown occurred on one of the running compressors. Although a trip did occur, the regularity of these trips has reduced since the correction of the earth mis-wire, to a level of no trips with 2 chillers running and one starting.

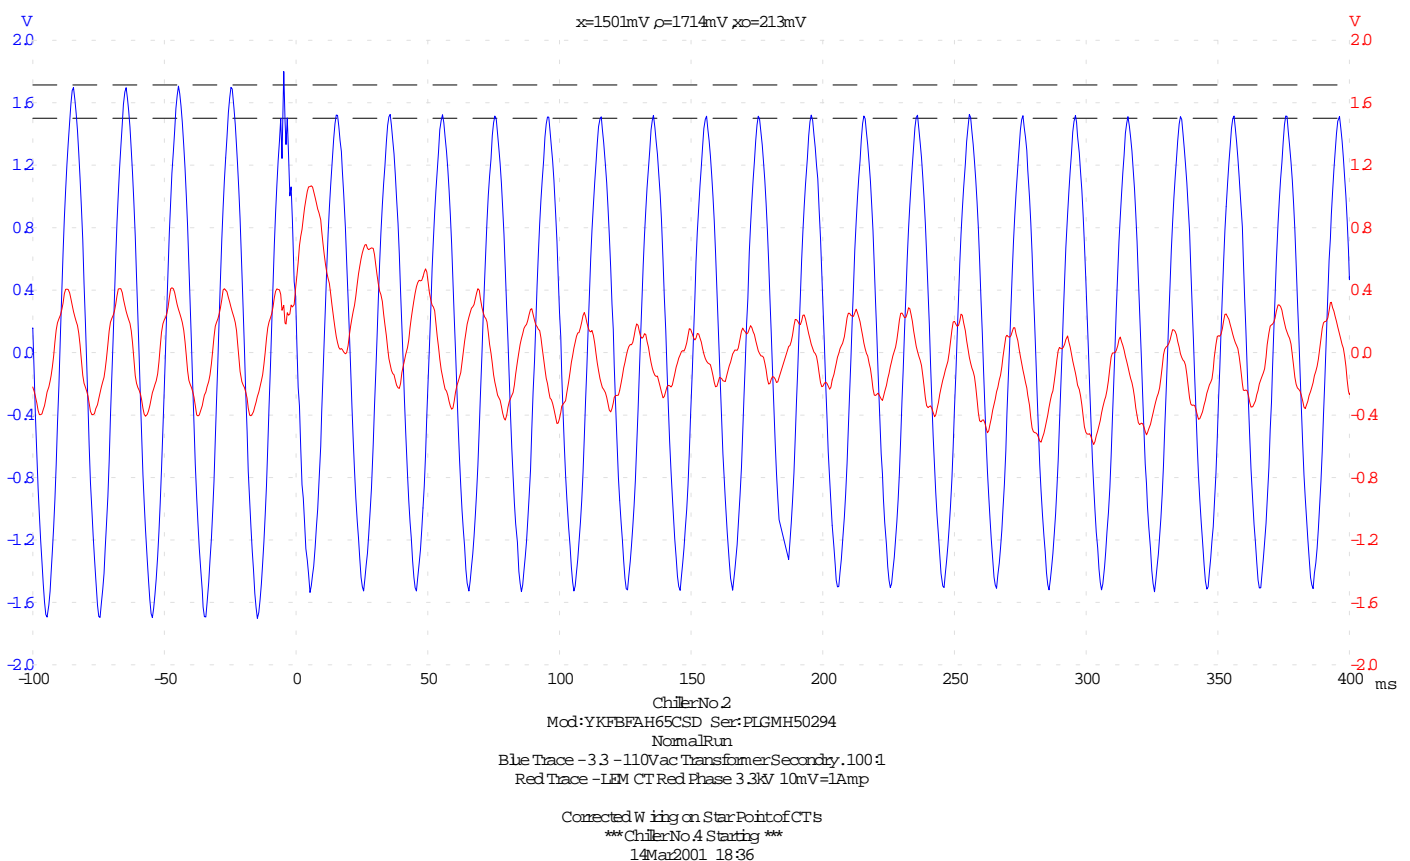
Although the Power Faults have reduced, the problem behind the trips is still present during every start of a compressor. This event is a reduction in the 3.3kV power supply to the running compressor when another Chiller starts. Although I did not directly measure the 3.3 kV network during one of these events, I did capture a large volt drop on a 3.3kV to 110Vac transformer output in the running chillers starter cabinet. This volt drop was measured as a 14% reduction on line voltage as reflected in Figure 04.

This captured event also shows the running chillers current waveform phase shifting at the instant the other Chiller is started. This can be explained as reduced Line Voltage at the instant the other starting compressor is flashed up, causing the running driveline to decelerate and the motor to be driven by the compressor and it's own rotor's inertia. The back EMF produced by the motor exceeds the line voltage and current from its windings is dumped back into the 3.3 kV Network, assisting the starting compressor to break away. This phase shift, an almost anti-phase distinguishes between the motor being a load to a generator in relation to the 3.3kV Network. This current dumping event lasts between 1 to 4 cycles. The oscillating current distortion after this event is a function of slip and acceleration whilst the running motor achieves synchronous speed.

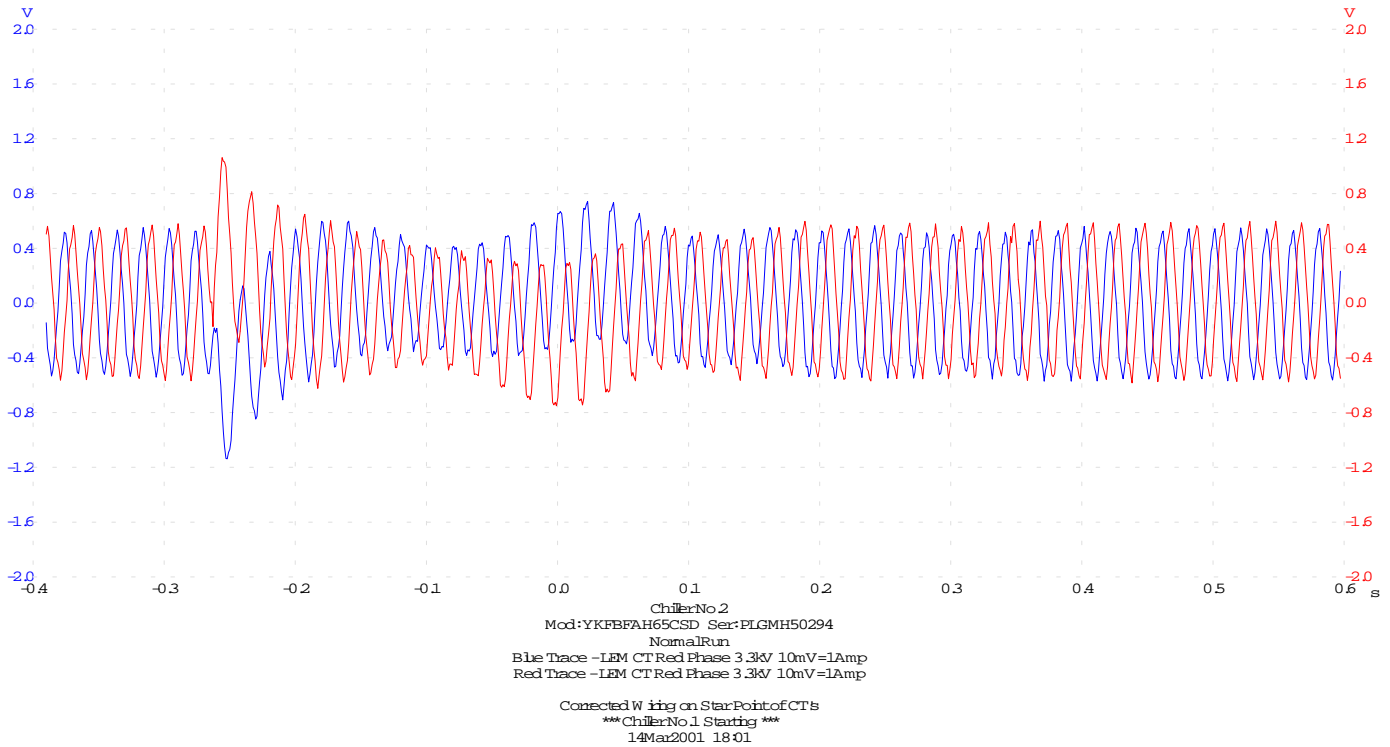
Figure 05.

The above event can be seen even better when using two current probes on the motor leads. It can be seen from all our data collected (Figure 05) that around 50 to 60 Amps RMS is being dumped back into the 3.3 kV Network, this calculates to around 160 kW of power.

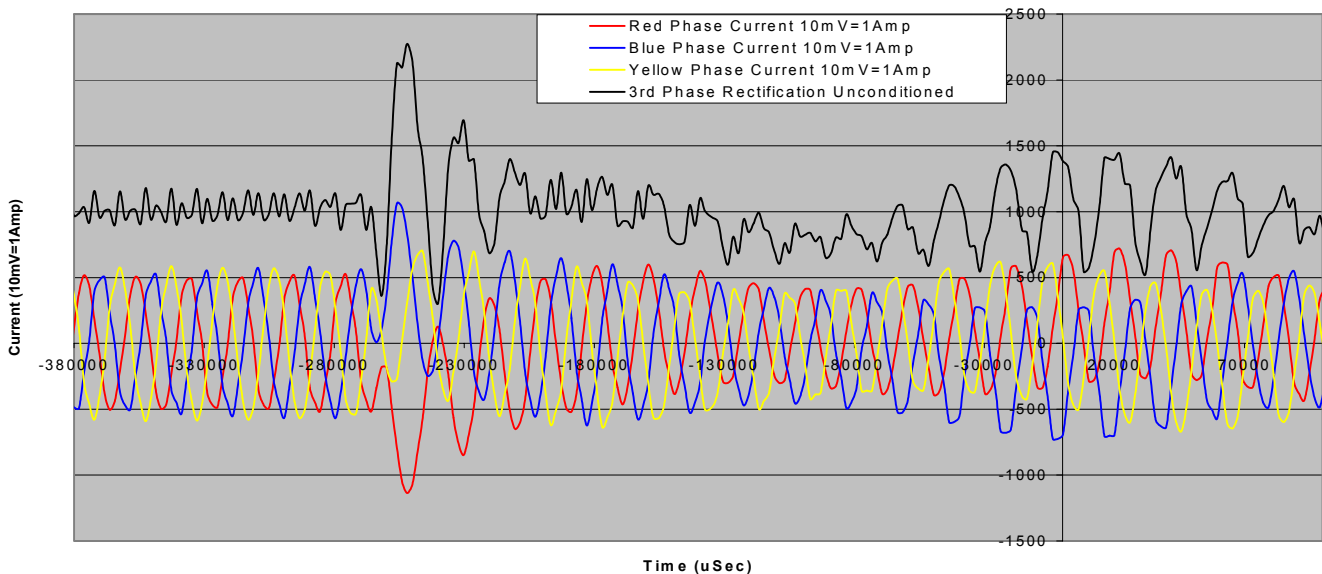
Figure 06.

To show you the theoretical resultant rectified waveform to the CM2 module of the above waveform we apply a unitary algorithm to calculate the third phase current draw. (Only 2 inputs on my oscilloscope) Using the absolute value from all three phases we can show the resultant rectified signal to the CM2 Module. (Figure 06) As you can see there are several major dips in the signal (Black Trace) that once exceed the 15% minimum current threshold will result in a Power Fault Shutdown. This theoretical calculated rectified signal takes the exact form as a captured scope trace as reflected in Figure 07. This suggests that even with the corrected earth wiring the real rectified waveform to the CM2 Module is very close to a trip condition as the 3.3kV Network now stands.

Three Phase Rectified Current
