Date:
To:
Att:
From: Steve Orlando.
Email: steve.orlando@fridgetek.com

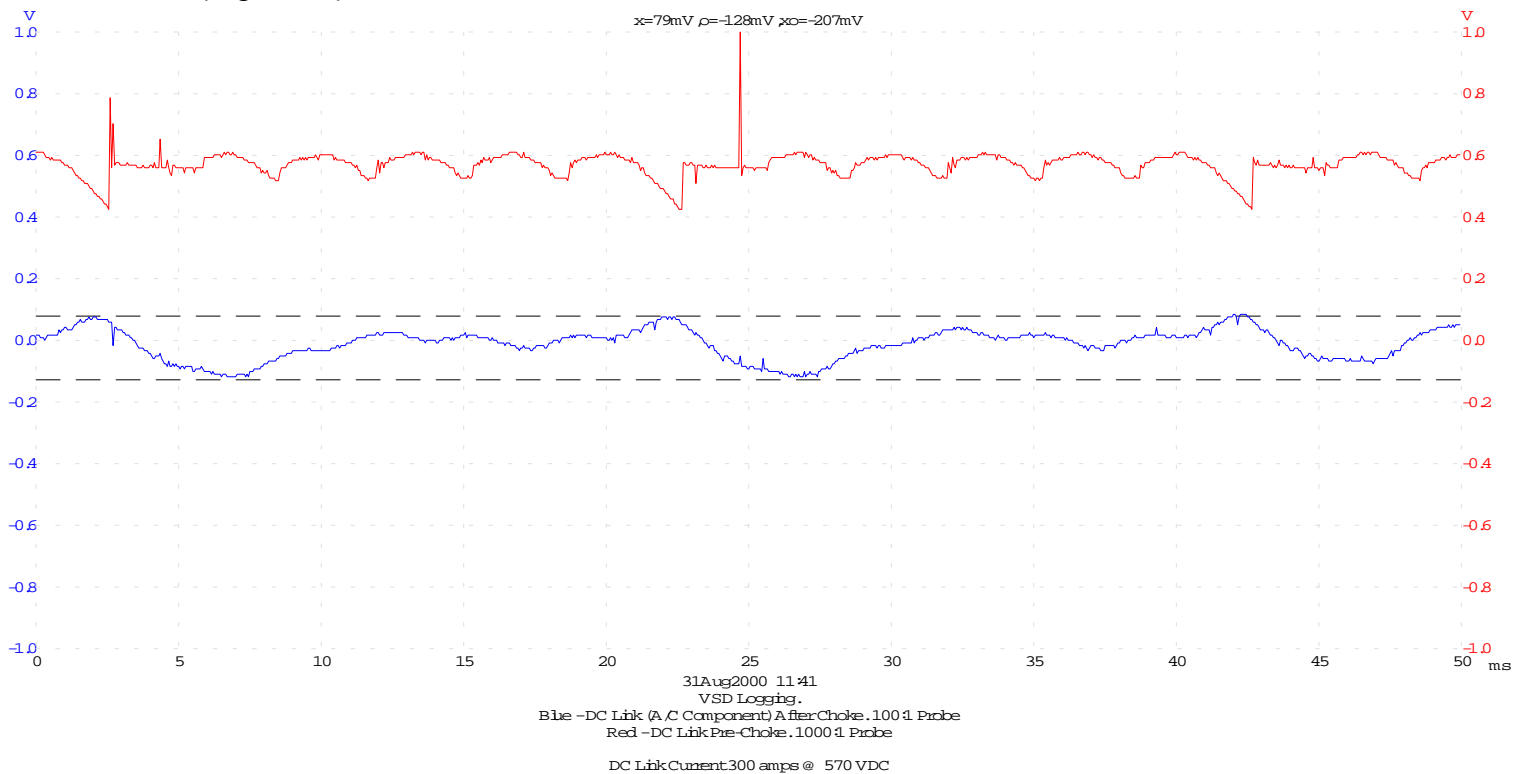
Figure 1.

After attending site yesterday with a differential probe, it became evident that a problem with the DC Link was present. The following scope trace shows the DC Link both before and after the Choke. (Figure 1.)

As the above representation shows, there was either a misfire or faulty diode in the SCR assembly. As it happens it was misfiring. This was causing an irregularity in the DC Link after the Choke in the magnitude of 20 Vdc.

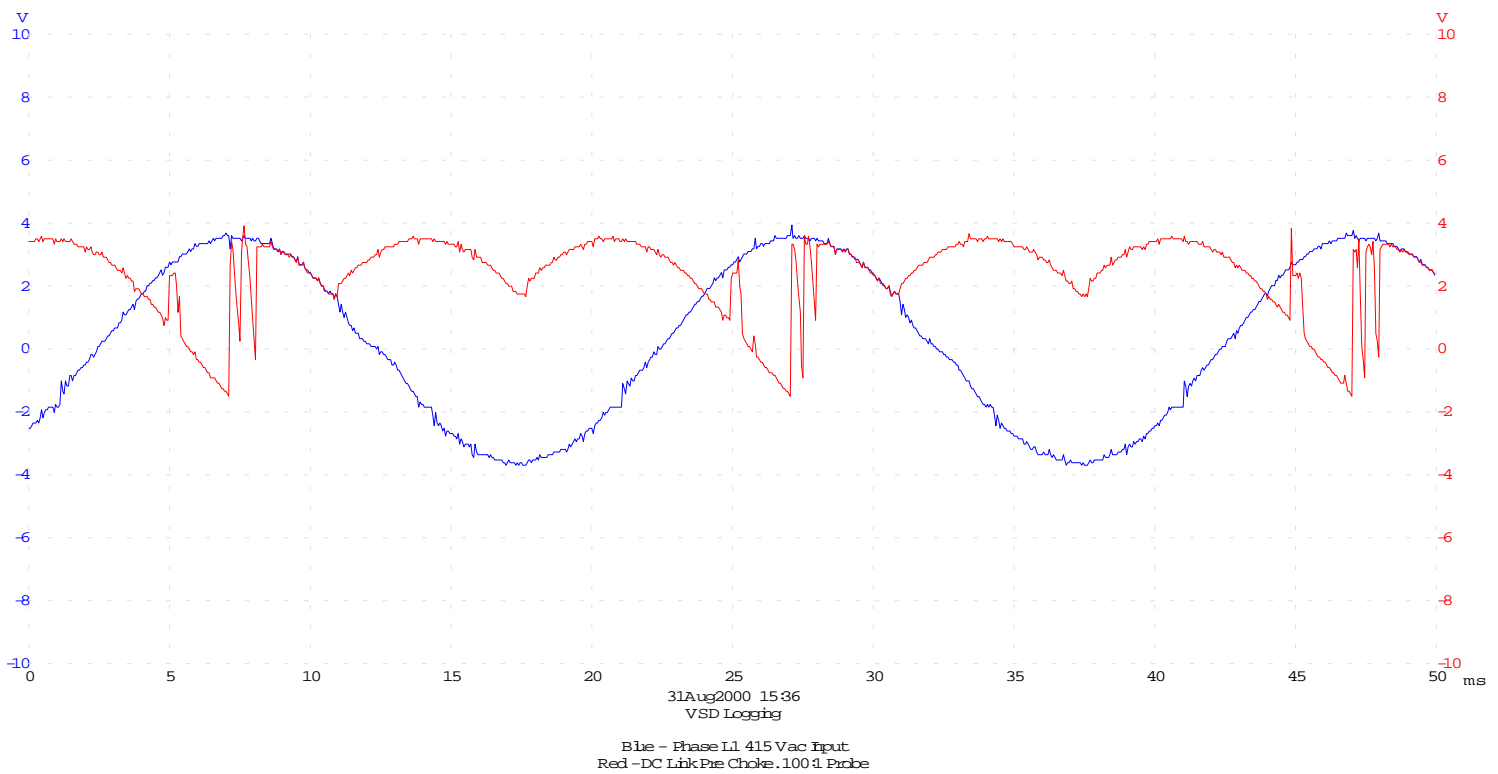
Figure 2.

The following scope trace determined that the SCR on L1 was causing the irregularity. (Figure 2). Further testing of it's gate showed that it was being misfired due to a mis-wiring of the loom.

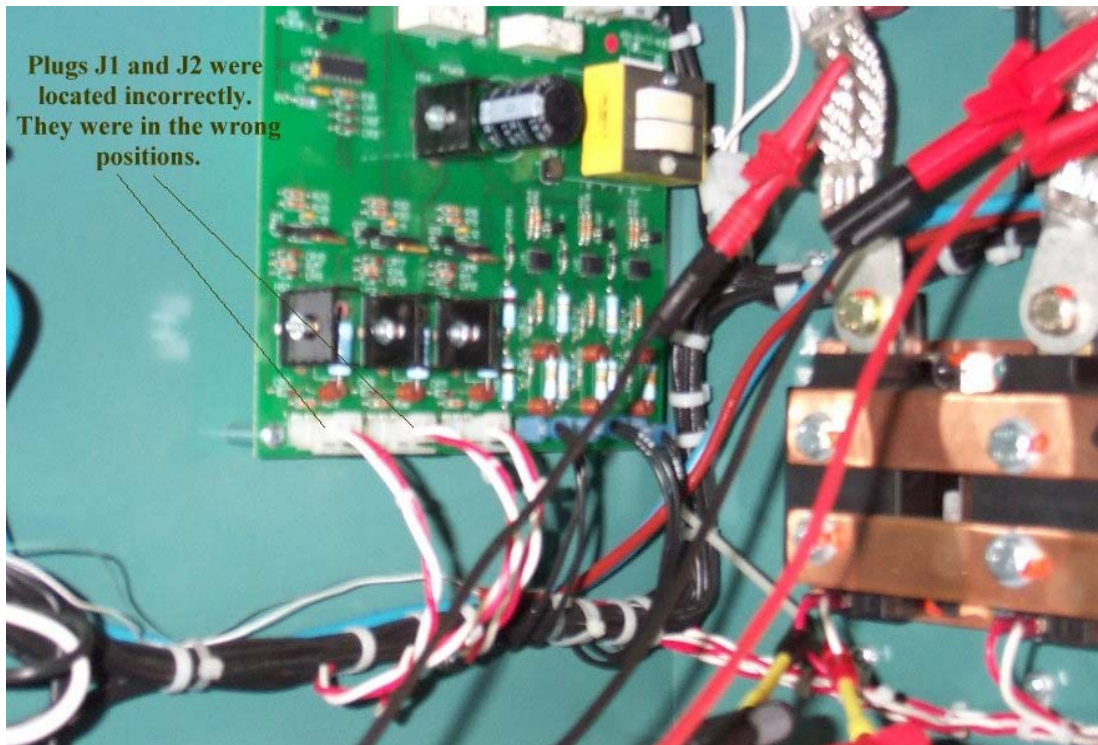
Figure 3.

Further investigation showed the Gate Plugs for Thyristor L1 and Thyristor L2 had been incorrectly located. That is swapped or mis-wired from factory. (Figure 3). The affected gate plugs are labelled J1 & J2.

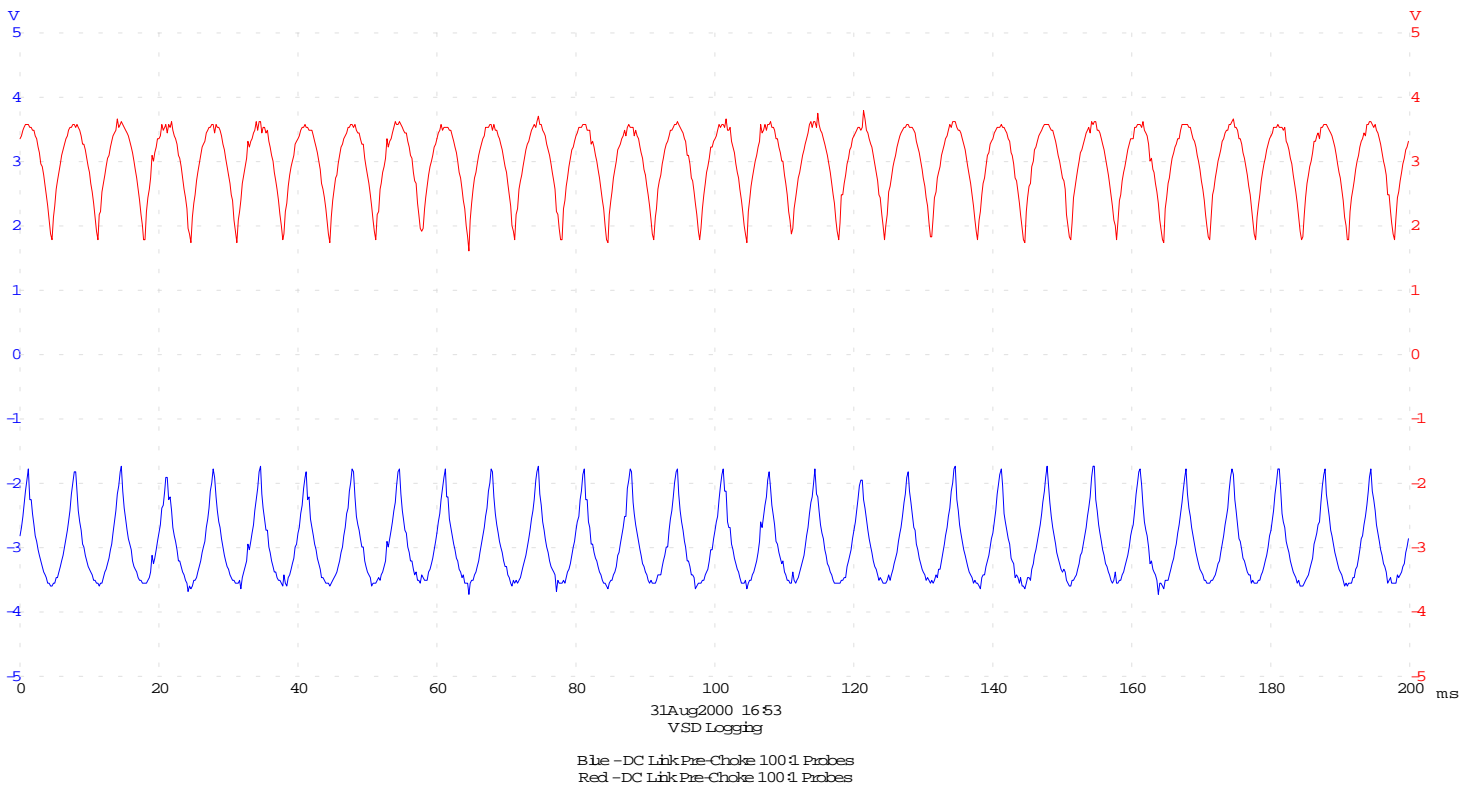
Figure 4.

Once the correction was made with the SCR's Gate connections the Pre-Choke DC Link began to perform as expected. (Figure 4). The DC Link after the Choke became very regular in all load conditions as reflected by the A/C component of the DC Current draw. (Figure 5).

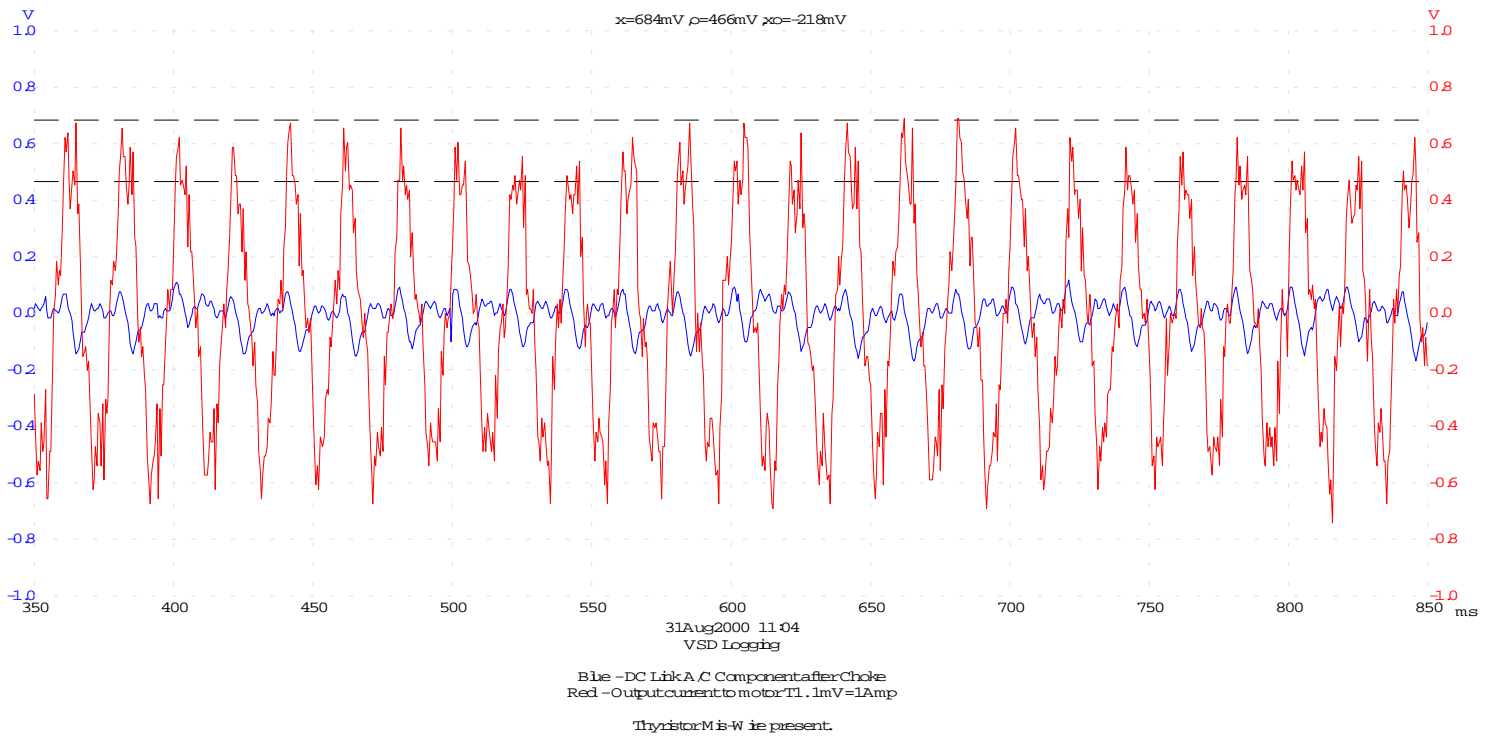
Figure 6.

The current imbalance as described in my previous report can now be explained due to our further site investigations and your confirmation that there could be a 20-fold effect on output current to DC LINK voltage variations. With the misfiring Thyristor L1 this imbalance can be illustrated by the following captured log. (Figure 6).

The above scope log shows a 22 V A/C Component in the DC Link after the Choke. This transcribes to a 230 Amp swing in T1 current Draw to the motor. This is only a 10 fold effect but the motor was only at 60% FLC. This current distortion moves through all 3-output phases as the DC Link Distortion influences them in a set sequence. This indicates that the frequency output never achieves exactly 50 Hz, as we did fix the output to 50 Hz. (Figure 7). The Red, Green and Yellow trace show the current imbalance between phase outputs at a scale of 700 Amps. The illustrated long period of imbalance may also be attributed to the scan time of the processor in relation to the moving distortion in the DC Link.

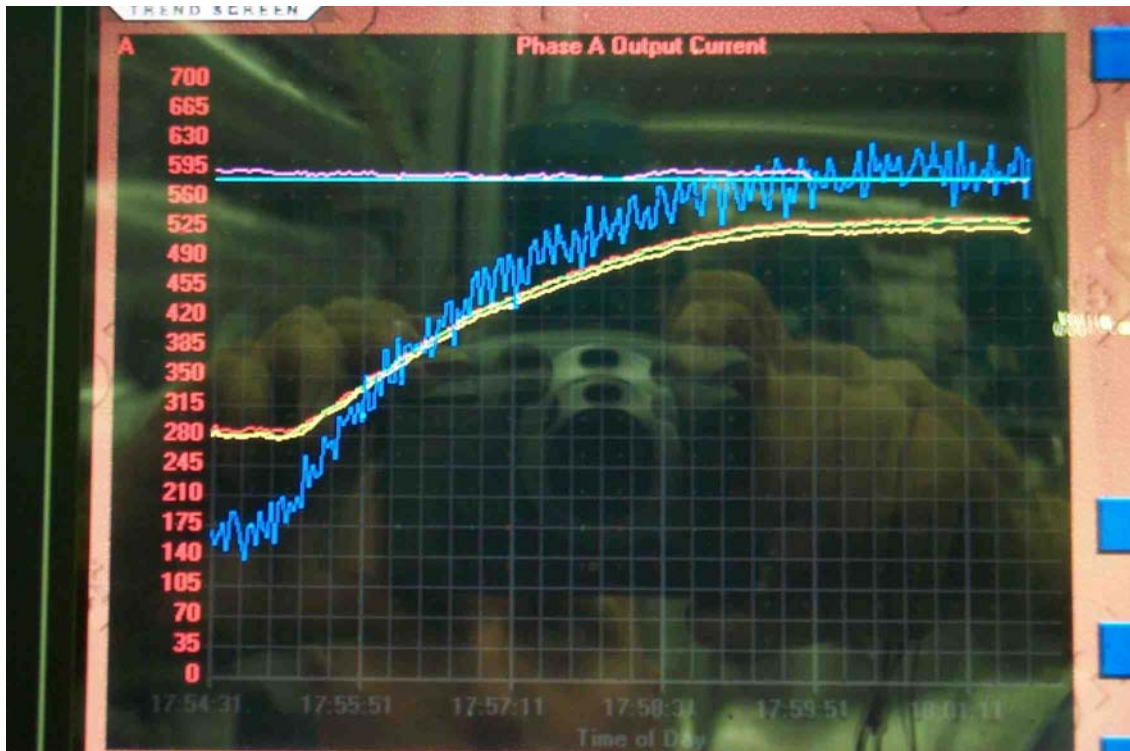
Figure 8.

With the corrected Thyristor L1, the Current Drawn from each output phase is balanced. Figure 8 shows how balanced the phases are at 95% FLA. Using the previous legend.

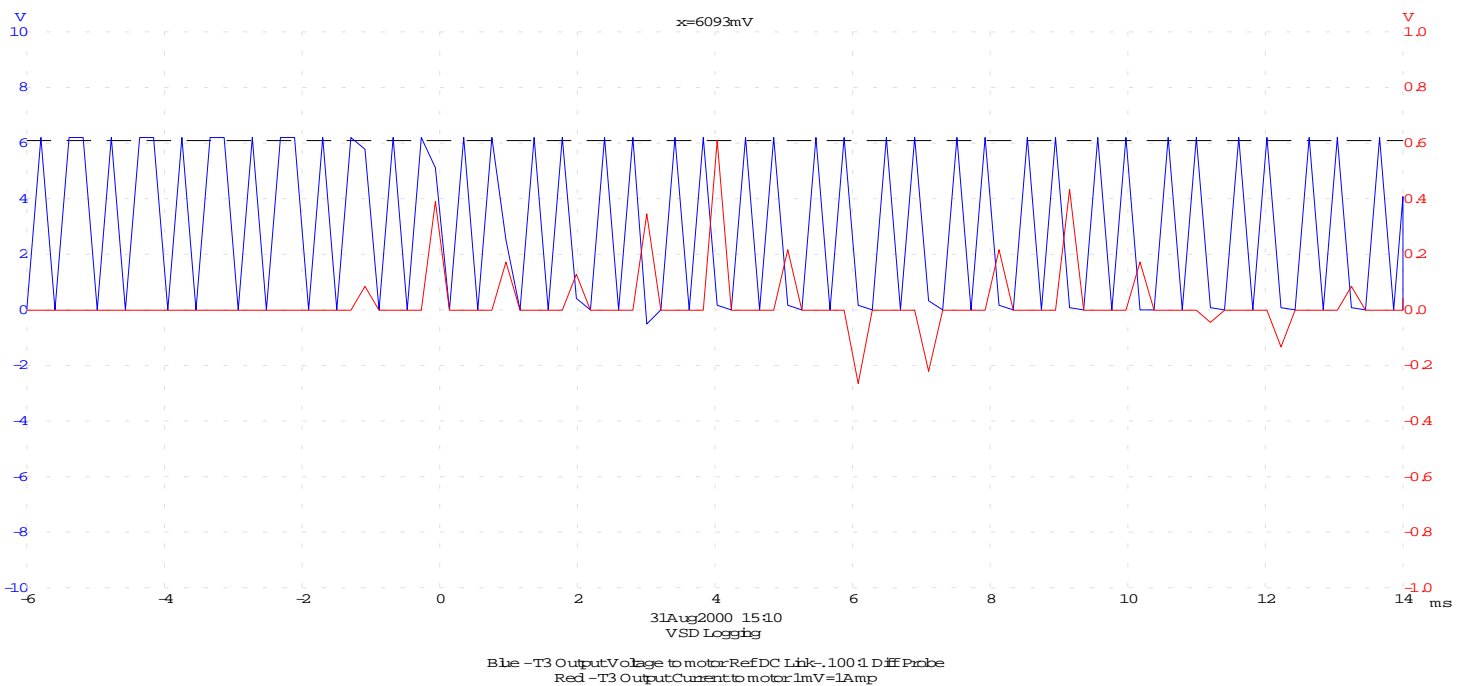
Figure 9.

We captured a starting inrush when the inertia of the motor was at zero. There seemed to be around a 600 Amp inrush. The resolution of the scope log is not that good so we cannot draw conclusions from this instance. We believe there may still a question mark over the suitability of the Leroy Somer Motor. We intend to visit site again next Tuesday to capture a more resolved log of Instantaneous Current at initial Rotor Inertia. (Figure 9).

With the motor suitability in mind, we cannot confirm that Instantaneous Current Trips will not still occur. The Thyristors and Transistors are all firing correctly and we have achieved a stable DC Link Voltage. If these trips still occur then the motor compatibility will then be in question. Currently the VSD and Chiller are in full automatic mode.
